Approved CR

IAA Des Moines  
1000 Armstrong Dr  
Branch No 536  
De Soto, IA 50069  
(515)823-0600/(515)823-0626  
WHOLESALE ASSESSMENT ONLY

Make/Model: **2011 FORD  
RANGER**  
Bodystyle/Series: **Extended Cab  
XLT**  
Color: **Blue**  
Mileage: **76,515  
(Verified)**  
Turn-in Mileage: -  
VIN: **1FTLR4FE1BPA07174**  
Work Order/  
Stock Number: **46304472**  
Customer: GSA Fleet Vehicle Sales  
1800 F Street NW  
Washington, DC 20405  
fleetsalesupport@gsa.gov  
Client Stock #: **G61-C6281**  
Vehicle Grade : **Grade 1.9**  
Remarks: -  
Announcements:

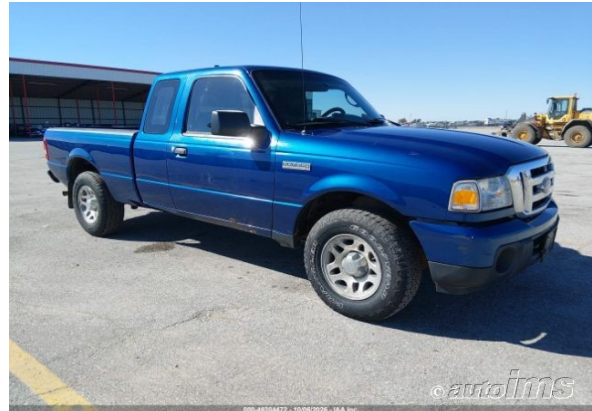
- BODY

RUST  
PRESENT
