Approved CR

IAA Des Moines  
1000 Armstrong Dr  
Branch No 536  
De Soto, IA 50069  
(515)823-0600/(515)823-0626  
WHOLESALE ASSESSMENT ONLY

Make/Model: **2017 FORD F-550 CHASSIS**  
Bodystyle/Series: **Regular Cab XL**  
Color: **White**  
Mileage: **33,086 (Verified)**  
Turn-in Mileage: **-**  
VIN: **1FDAF5GT9HED73399**  
Work Order/  
Stock Number: **46279868**  
Customer: **GSA Fleet Vehicle Sales  
1800 F Street NW  
Washington, DC 20405  
fleetsalesupport@gsa.gov**  
Client Stock #: **G32-0373U**  
Vehicle Grade : **Grade 2.2**  
Remarks: **-**  
Announcements:

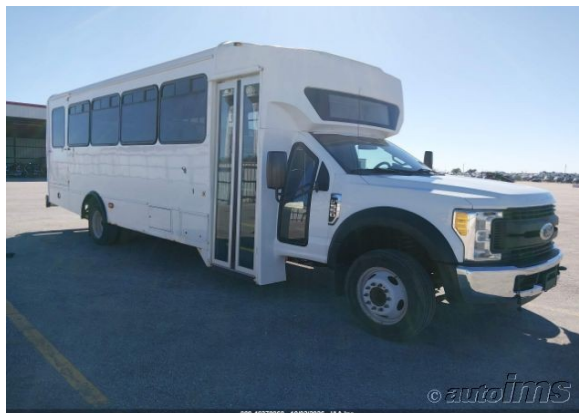
- RUST ON ROOF
- CHECK ENGINE LIGHT ON
- HAIL DAMAGE
