Approved  
CR

IAA Salt Lake City  
1800 South 1100 West  
Branch No 342  
Ogden, UT 84401-0258  
(801) 399-2818/(801) 393-2325  
WHOLESALE ASSESSMENT ONLY

Make/Model: **2018 RAM 3500 CHASSIS**  
Bodystyle/Series: **- TRADESMAN/SLT**  
Color: **White**  
Mileage: **27,322 (Verified)**  
Turn-in Mileage: **-**  
VIN: **3C7WRTAL7JG272913**  
Work Order/  
Stock Number: **46190999**  
Customer: **GSA Fleet Vehicle Sales  
1800 F Street NW  
Washington, DC 20405  
fleetsalesupport@gsa.gov**  
Client Stock #: **G631208V**  
Vehicle Grade : **Grade 1.2**  
Remarks: **-**  
Announcements:

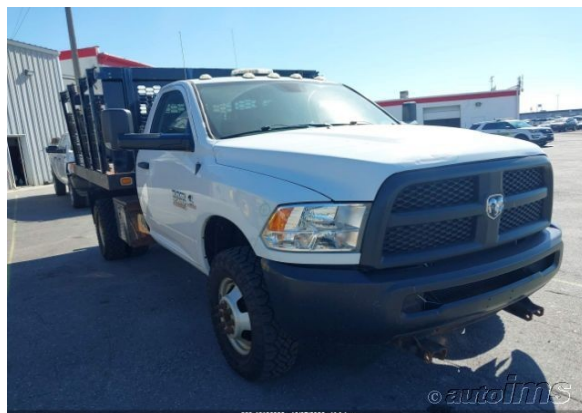
- STEERING AND SUSPENSION REPAIRS NEEDED.
- UNECONOMICAL TO REPAIR
- NEEDS NEW ENGINE
