Approved CR

IAA Denver East  
8510 Brighton Rd.  
Branch No 374  
Commerce City, CO 80022  
(303) 287-9737/(303) 287-1214  
WHOLESALE ASSESSMENT ONLY

Make/Model: **2015 FORD  
F-250**  
Bodystyle/Series: **Extended Cab  
XL**  
Color: **Silver**  
Mileage: **38,293  
(Verified)**  
Turn-in Mileage: **-**  
VIN: **1FD7X2B68FED19709**  
Work Order/  
Stock Number: **46311867**  
Customer: **GSA Fleet Vehicle Sales  
1800 F Street NW  
Washington, DC 20405  
fleetsalesupport@gsa.gov**  
Client Stock #: **G63B0976**  
Vehicle Grade : **Grade 2.6**  
Remarks: **-**  
Announcements: **-**  
Certification : **-**  
Req. Prev. Repair **-**  
Order: **-**

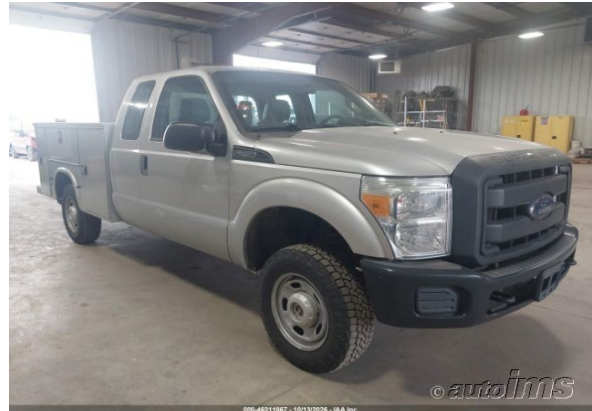
| Photo | Item | Damage | Action | Severity |
|---|---|---|---|---|
| | Rf Door Panel Trim/Mld | Gouged | - | < 1/8 Inch |
| | Front Metal Bumper Painted | Chipped | - | 4 |
| | Tailgate | Heavy Scratch | - | 1 To 2 Inches |
| | Right Front Door | Dent(S) W/ Paint Dmg | - | 5 To 6 Inches |
| | Hood | Hail Damage | - | 10 Or More |

| Chargeable Damages | | | | |
|---|---|---|---|---|
| | Left Bed Side | Dent(S) W/ Paint Dmg | - | 1 To 2 Inches |
| | Inside Bed | Peeling | - | 7 To 8 Inches |
| | Rear Metal Bumper Painted | Rust | - | > 12 Inches |
