Approved CR

IAA Denver East  
8510 Brighton Rd.  
Branch No 374  
Commerce City, CO 80022  
(303) 287-9737/(303) 287-1214  
WHOLESALE ASSESSMENT ONLY

Make/Model: **2015 FORD F-550 CHASSIS**  
Bodystyle/Series: **Regular Cab XL**  
Color: **White**  
Mileage: **23,929 (Verified)**  
Turn-in Mileage: **-**  
VIN: **1FDUF5GY9FEA16858**  
Work Order/ Stock Number: **46276994**  
Customer: **GSA Fleet Vehicle Sales  
1800 F Street NW  
Washington, DC 20405  
fleetsalesupport@gsa.gov**  
Client Stock #: **G710097X**  
Vehicle Grade : **Grade 1.5**  
Remarks: **-**  
Announcements:

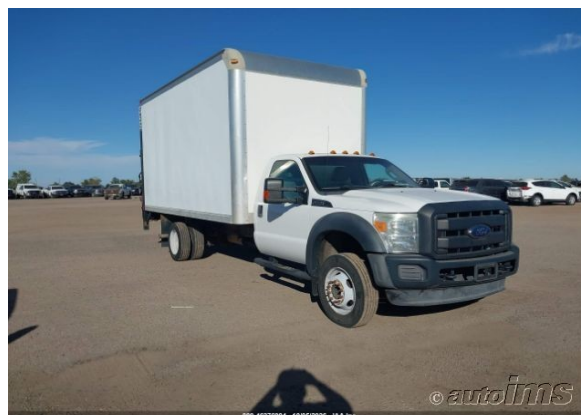
**• RUST ON LIFTGATE AND REAR BODY PANEL**

| Chargeable Damages | | | | |
|---|---|---|---|---|
| | Tailgate | Rust | - | Severe Damage |
| | Exterior Rear Body Panel | Rust | - | > 12 Inches |

| Photo | Item | Damage | Action | Severity |
|---|---|---|---|---|
| | Lift Gate | Peeling | - | > 12 Inches |
