Approved  
CR

Akron Auto Auction  
2471 Ley Drive  
Akron, OH 44319  
3304365819/(330) 773-3921  
lbeth@akronautoauction.com  
WHOLESALE ASSESSMENT ONLY

Make/Model: **2018  
HYUNDAI  
IONIQ  
HYBRID  
4 Door Sedan**

VIN: **KMHC65LC0JU075852**

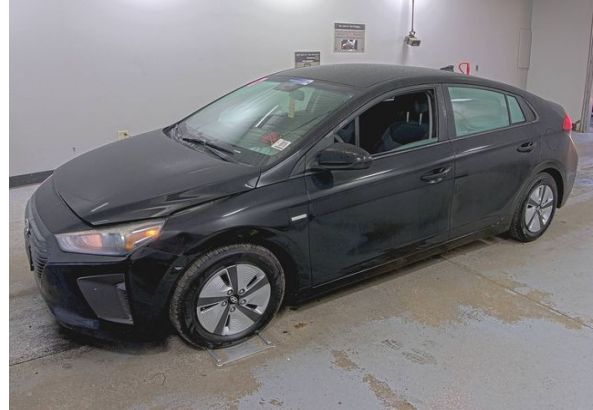
Vehicle Grade : **Grade 2.8**

AutoGrade : **2.8 - Below  
Average**

Drivable: Yes

UniBody/Frame Damage: NO As Is 100K Miles: NO
