Approved CR

IAA San Diego  
2380 Britannia Blvd  
Branch No 116  
San Diego, CA 92154  
(619) 710-2866/(619) 710-2878  
WHOLESALE ASSESSMENT ONLY

Make/Model: **2024 DODGE  
DURANGO**  
Bodystyle/Series: **Sport Utility  
Vehicle  
PURSUIT  
AWD**  
Color: **White**  
Mileage: **90,779  
(Verified)**  
Turn-in Mileage: **-**  
VIN: **1C4RDJFG8RC182631**  
Work Order/  
Stock Number: **46217810**  
Customer: **GSA Fleet Vehicle Sales  
1800 F Street NW  
Washington, DC 20405  
fleetsalesupport@gsa.gov**  
Client Stock #: **G62B3381**  
Vehicle Grade : **Grade 3.1**  
Remarks: **-**

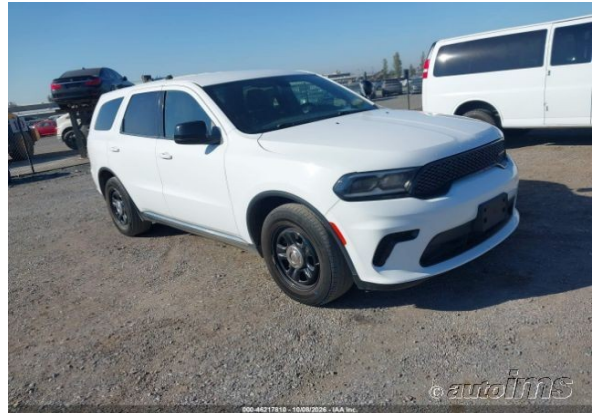
• CONDITION  
UNKNOWN  
• FORMER  
POLICE  
VEHICLE  
• REAR DOORS  
/ WINDOWS  
INOPERABLE  
MAY BE  
INOPERABLE  
• SALVAGE  
STAMPED  
CERTIFICATE  
TO OBTAIN  
TITLE WILL  
BE ISSUED
