Approved  
CR

IAA Syracuse  
8459 Brewerton Road  
Branch No 628  
Cicero, NY 13039  
(315) 699-2622/(315) 699-5481  
WHOLESALE ASSESSMENT ONLY

Make/Model: **2019 FORD F-250**  
Bodystyle/Series: **Regular Cab XL**  
Color: **Brown**  
Mileage: **78,413 (Verified)**  
Turn-in Mileage: **-**  
VIN: **1FTBF2B68KED43729**  
Work Order/  
Stock Number: **46326554**  
Customer: **GSA Fleet Vehicle Sales**  
**1800 F Street NW**  
**Washington, DC 20405**  
**fleetsalessupport@gsa.gov**

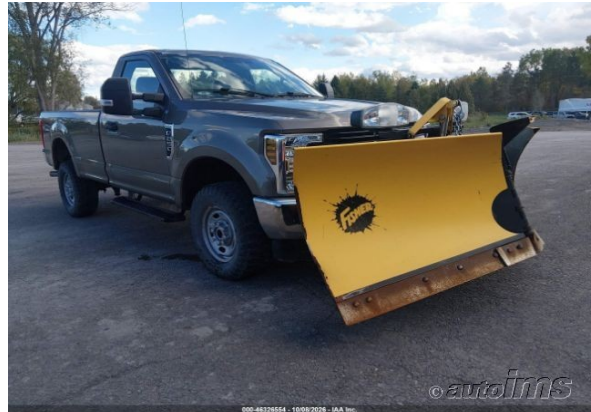
Vehicle Grade : **Grade 2.5**

- repairs may be needed
- ANNOUNCEMENTS:  
Warning indicator on
- please check OBDII  
report on IAA site.
- /Rust
