Approved  
CR

IAA Eugene  
1000 Bethel Drive  
Branch No 309  
Eugene, OR 97402  
(541) 689-4000/(541) 689-0083  
WHOLESALE ASSESSMENT ONLY

Make/Model: **2005 DODGE  
RAM 1500**

VIN: **1D7HU18P35J571830**

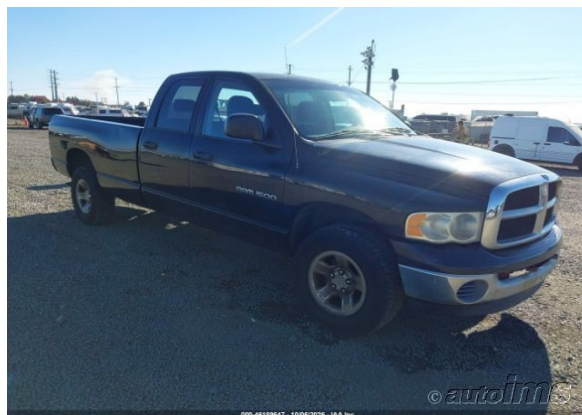
Vehicle Grade : **Grade 2.3**

| Photo | Item | Damage | Action | Severity |
|---|---|---|---|---|
| | Rear Metal Bumper Chrome | Severe Damage | - | Replacement Required |
| | Tailgate | Severe Damage | - | Replacement Required |
| | Left Bed Side | Multiple Scratches Heavy | - | 2 |

| Photo | Item | Damage | Action | Severity |
|---|---|---|---|---|
| | Left Rear Door | Dent(S) W/ Paint Dmg | - | 2 To 3 Inches |
| | Roof Panel | Chipped | - | 2 |
| | Front Bumper Cover Upper | Multiple Scratches Heavy | - | 2 |
| | Front Metal Bumper Chrome | Rust | - | Severe Damage |
| | Right Qtr Panel | Dent(S) W/ Paint Dmg | - | > 12 Inches |
