Approved CR

IAA Anchorage  
1446 W Mystery Ave  
Branch No 372  
Wasilla, AK 99654  
(907)312-5580/(907)312-5680  
WHOLESALE ASSESSMENT ONLY

Make/Model: **2018 FORD  
TRANSIT-350**  
Bodystyle/Series: **Cargo Van -**  
Color: **White**  
Mileage: **11,276  
(Verified)**  
Turn-in Mileage: **-**  
VIN: **1FTBW2XM8JKB07251**  
Work Order/  
Stock Number: **46275626**  
Customer: **GSA Fleet Vehicle Sales  
1800 F Street NW  
Washington, DC 20405  
fleetsalesupport@gsa.gov**  
Client Stock #: **G431959V**  
Vehicle Grade : **Grade 4.0**  
Remarks: **-**  
Announcements: **-**  
Certification : **-**  
Req. Prev. Repair **-**  
Order:

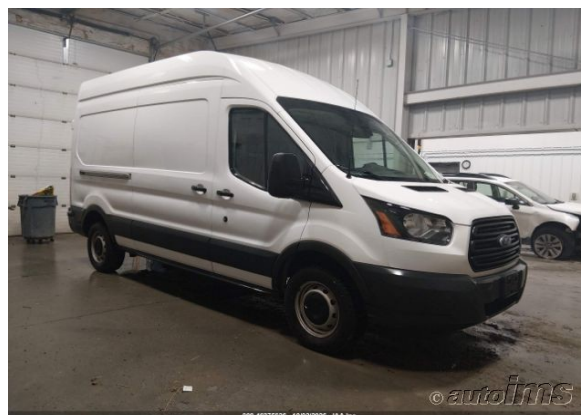
| Chargeable Damages | | | | |
|---|---|---|---|---|
| | Right Front Wheel | Corrosion | - | 3 To 4 Inches |

| Chargeable Damages | | | | |
|---|---|---|---|---|
| | Right Front Door | Chipped | - | 2 |
| | Left Front Wheel | Curb Rash | - | > 12 Inches |
| | Left Rear Wheel | Curb Rash | - | 4 To 5 Inches |
| | Right Rear Wheel | Corrosion | - | 1/2 To 1 Inch |
