Approved CR

Make/Model: **2021  
HYUNDAI  
ELANTRA**

VIN: **5NPLL4AG8MH050810**

Vehicle Grade : **Grade 2.4**

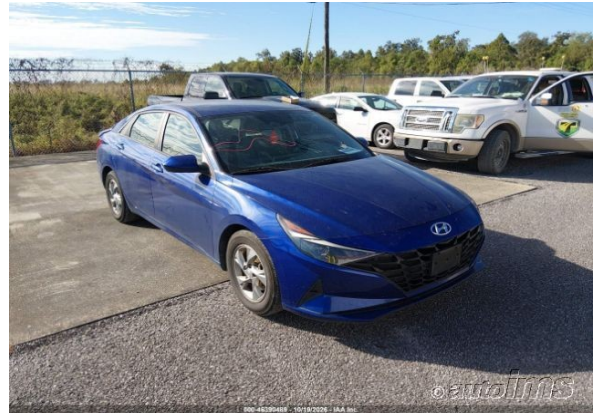
- Warning light  
see IAA  
Condition  
Report; crack  
in windshield

| Photo | Item | Damage | Action | Severity |
|---|---|---|---|---|
| | Warning Light - Air Bag | On | - | Unacceptable |

| Photo | Item | Damage | Action | Severity |
|---|---|---|---|---|
| | Hood | Bug Damage | - | Repair Required |
| | Front Bumper | Bug Damage | - | Repair Required |
| | Right Front Fender | Multiple Scratches Light | - | 3 |
| | Right Rocker Panel | Multiple Scratches Heavy | - | 3 |
| | Right Qtr Panel | Chipped | - | 3 |

| Chargeable Damages | | | | |
|---|---|---|---|---|
| | Right Rear Wheel | Curb Rash | - | 3 To 4 Inches |
| | Left Rear Wheel | Curb Rash | - | 1 To 2 Inches |
| | Left Front Wheel | Curb Rash | - | 2 To 3 Inches |
| | Windshield | Cracked | - | > 12 Inches |
| | Deck Lid | Dent(S) W/ Paint Dmg | - | > 12 Inches |
